Channel Modification For Fish Passage On Umatilla River

**Supplement to
Final
Report
1985**

CHANNEL MODIFICATION FOR FISH PASSAGE
ON
UMATILLA RIVER

William L. Sanguine, Geologist
U.S. Army Corps of Engineers
Building 602 City-County Airport
Walla Walla, Washington 99362-9265

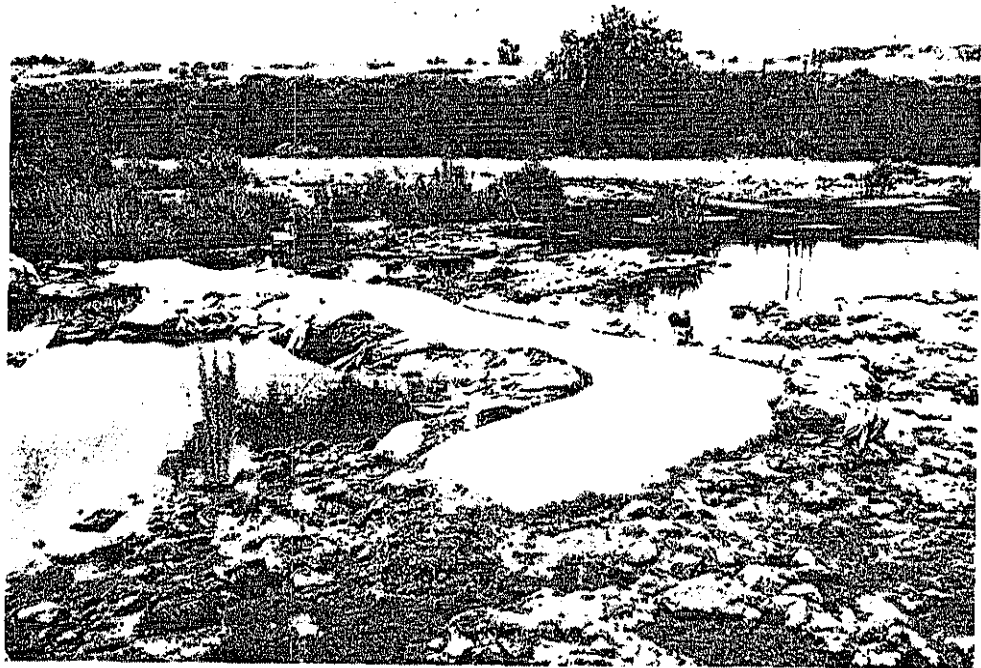
**PHOTO 43: A SIDE CHANNEL NEAR STA. 98+25
BLOCKED OFF WITH CONCRETE**

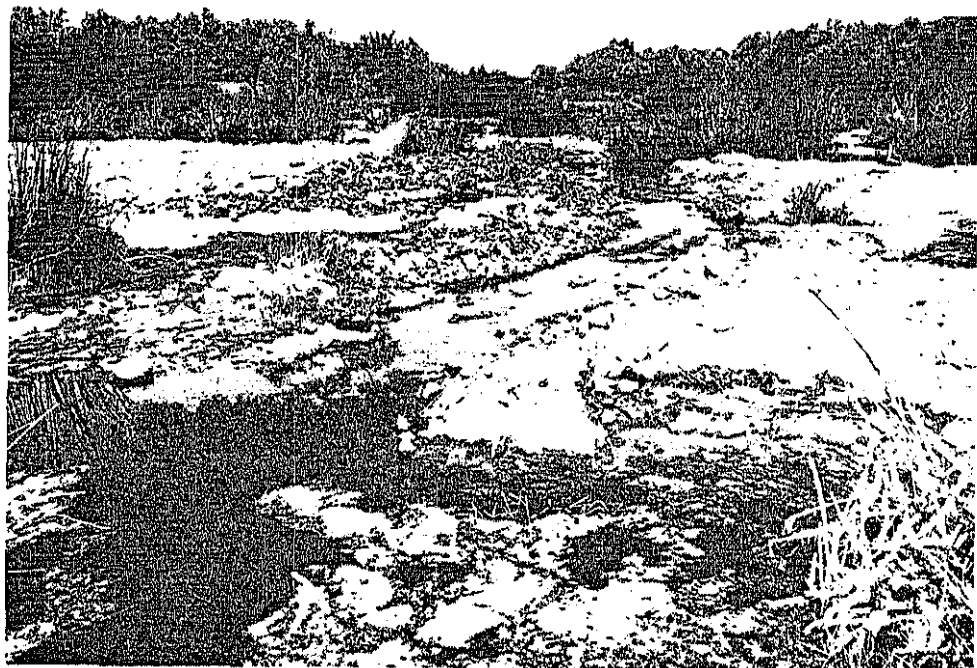
**PHOTO 44: VIEW OF CHANNEL DOWNSTREAM
OF STA. 29+50 AS CONSTRUCTED WITH HOERAM.**

b. Provide channel improvement between approximate Stations 29+50 and 47+50 and between approximate Stations 98+00 and 100+00. Channel improvements include removal of reaches of solid rock, widening and/or deepening of existing channel, and removal of high spots and protrusions in the existing channel to provide a final minimum channel width of 3-feet wide by 1-foot deep. Channel excavation may be required at some locations to divert water into the main channel from small pools and other channels. The primary objective is to develop a channel between the above stated stations and excavation shall not be performed to divert water from side channels or pools until the Contractor has assured himself that the entire length of main channel will be excavated and the total excavation will not exceed the estimated 1,075 linear feet.

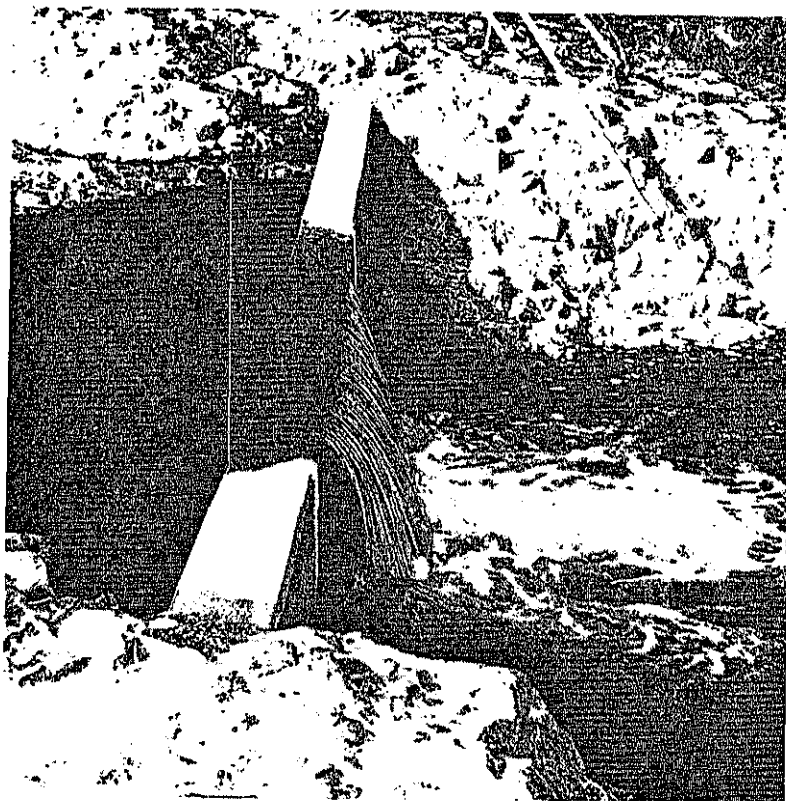
PHOTO 45: SIDE VIEW OF WEIR NO. 1

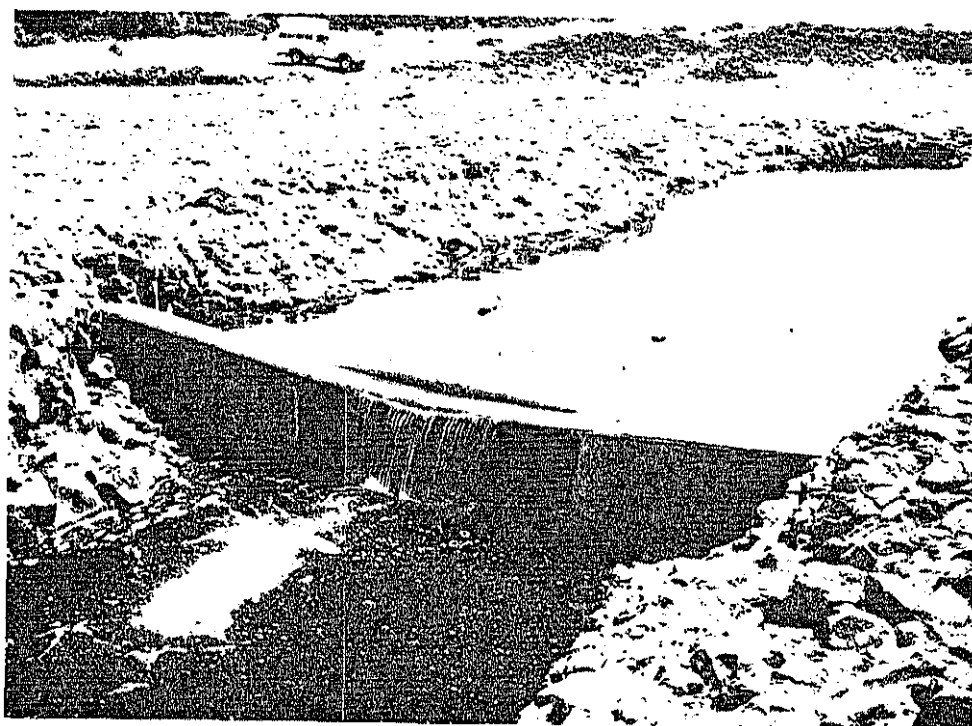
PHOTO 46: CLOSE VIEW OF WEIR NO. 2

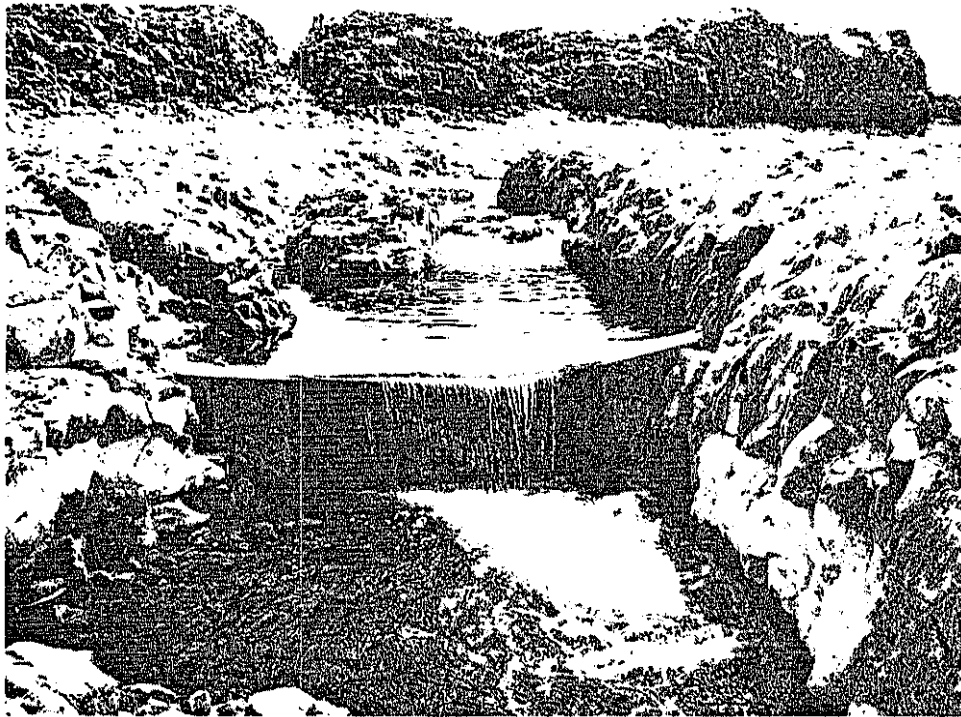
PHOTO 47: LOOKING UPSTREAM AT WEIR NO. 3

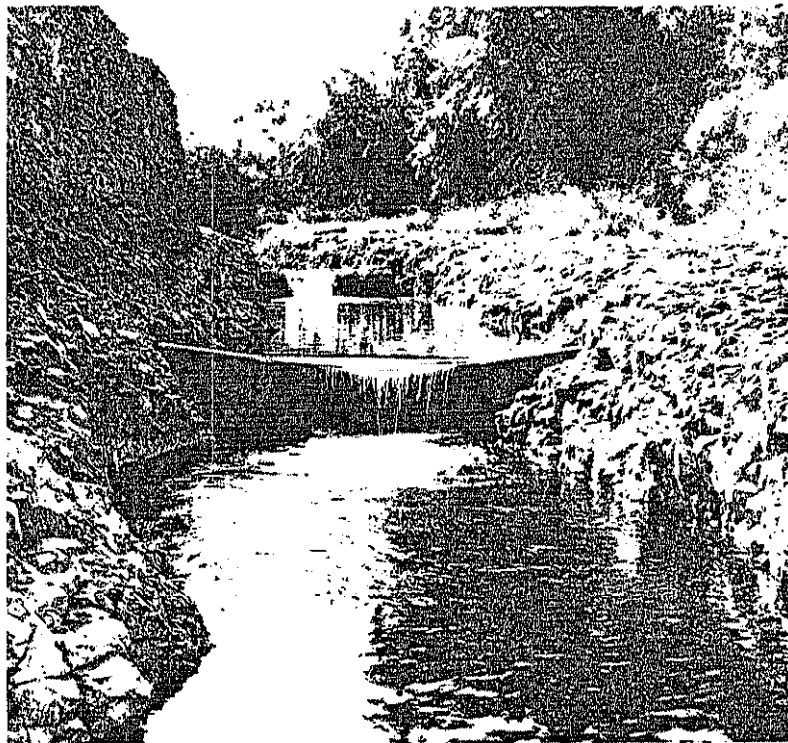
**PHOTO 48: VIEW OF WEIR NO. 4 AND
BLASTED WEIR ABOVE IT**

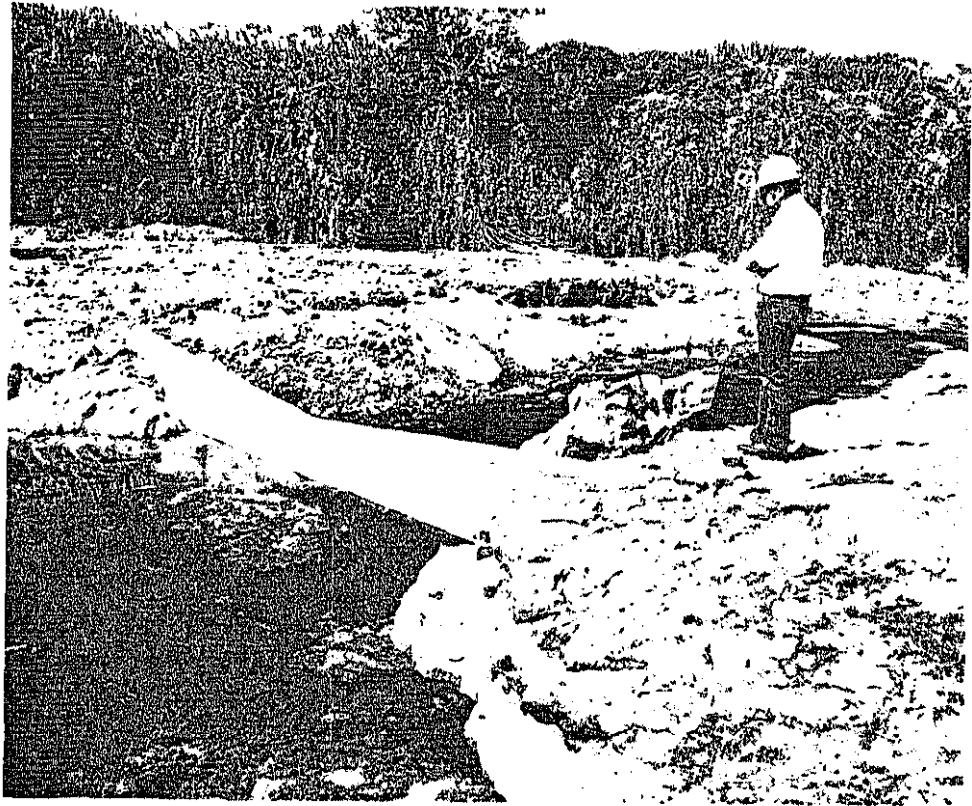
PHOTO 49: OBLIQUE VIEW OF WEIR NO. 5

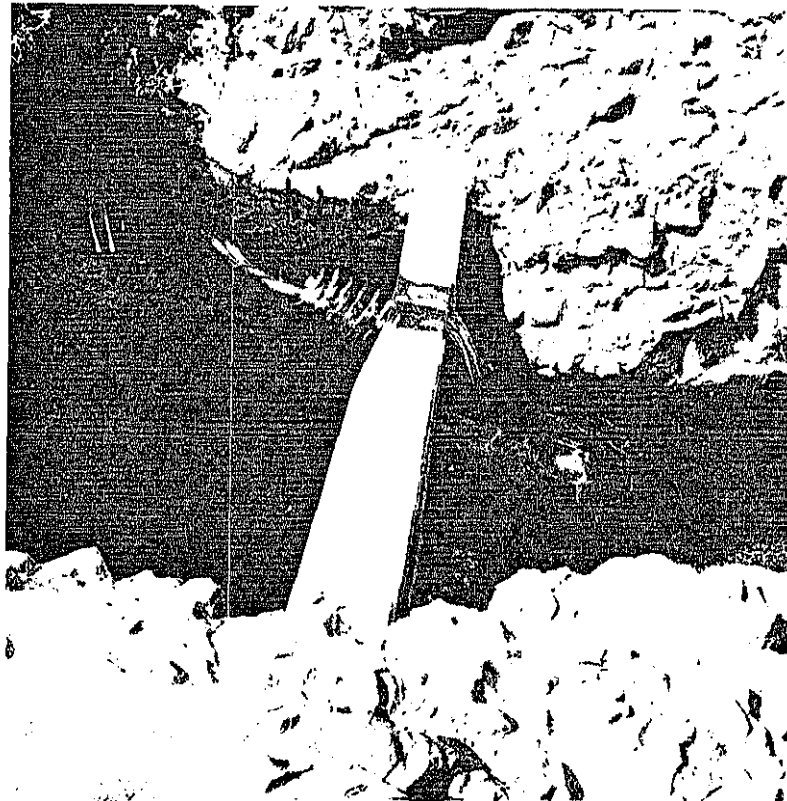
PHOTO 50: SIDE VIEW OF WEIR NO. 6

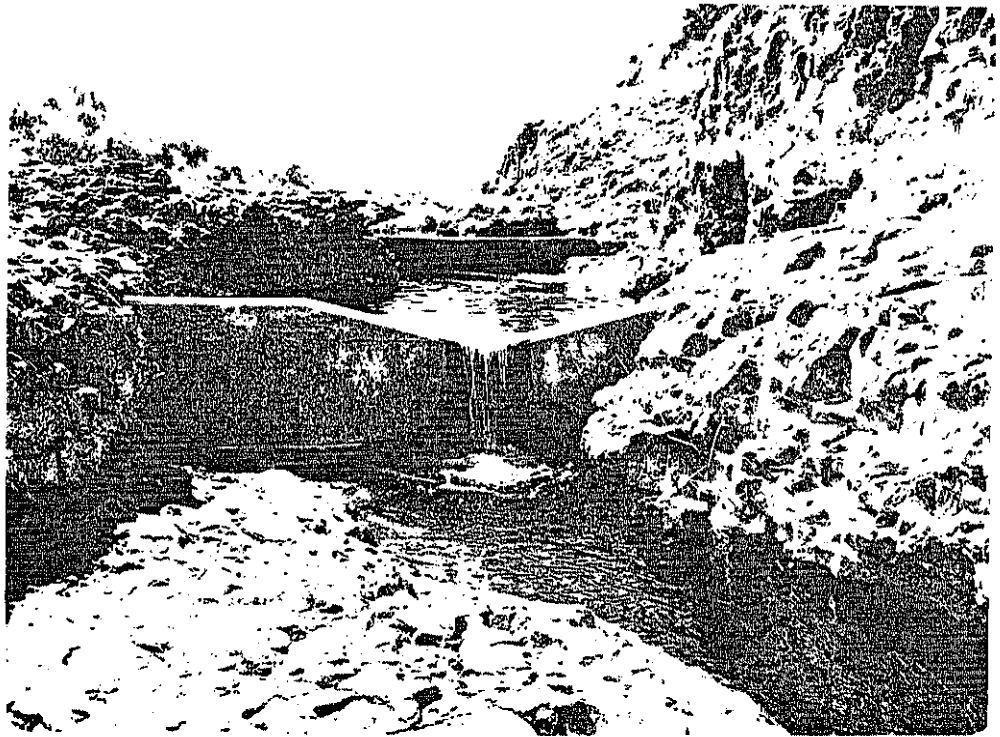
PHOTO 51: UPSTREAM VIEW OF WEIRS 6 AND 7

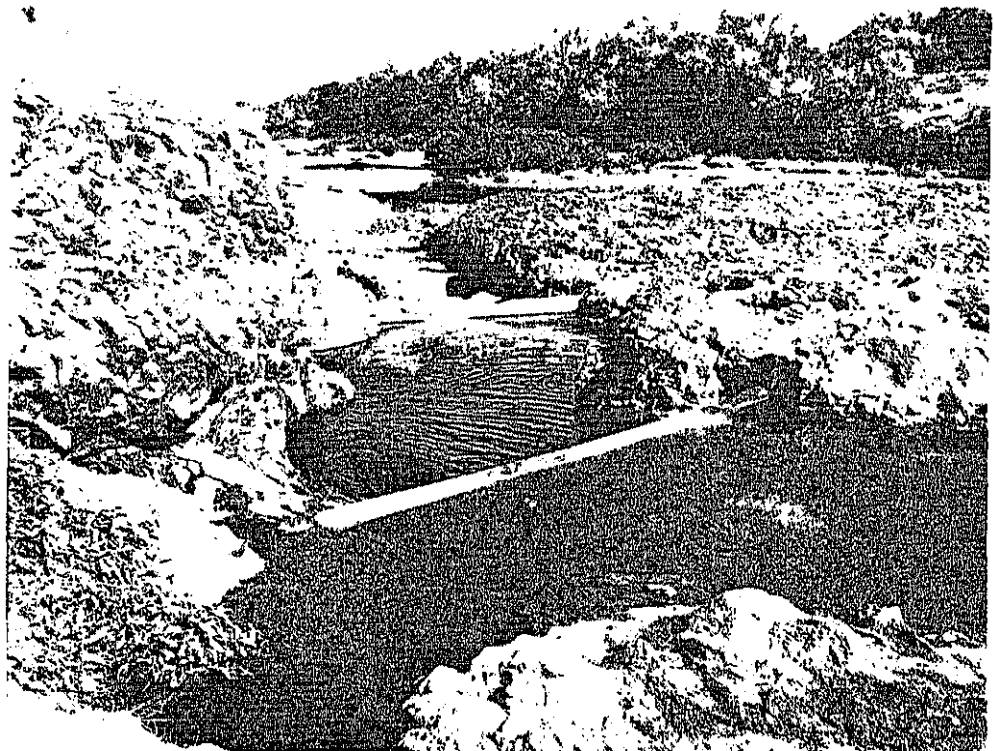
PHOTO 52: DOWNSTREAM VIEW OF WEIRS 7 AND 6

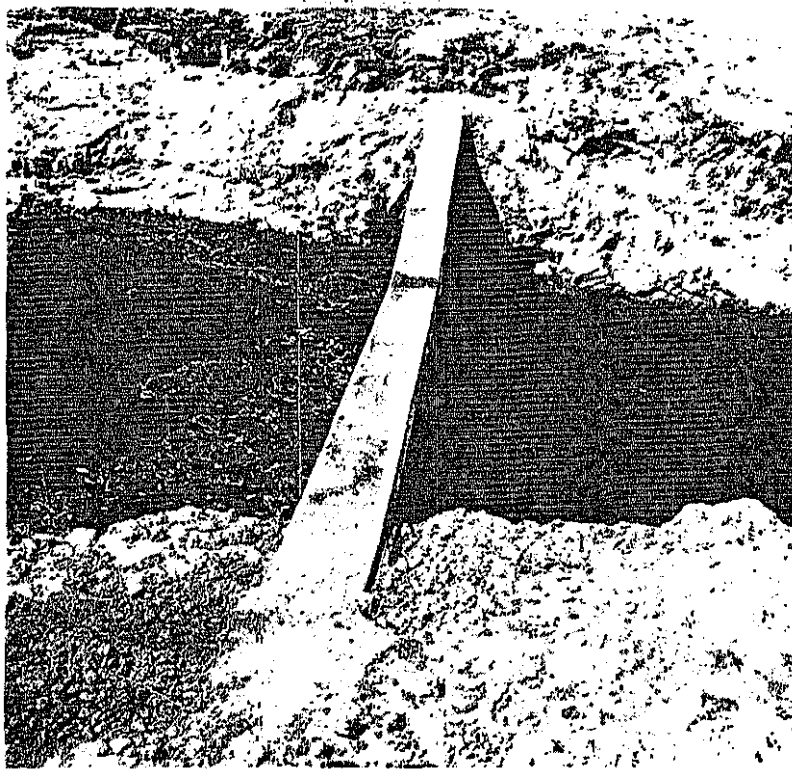
PHOTO 53: SIDE VIEW OF WEIR NO. 8

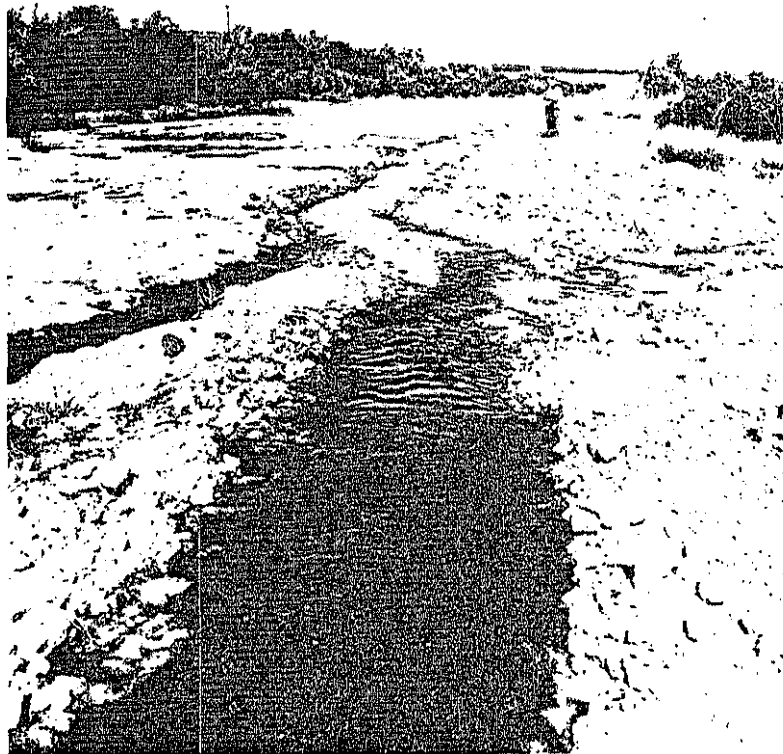
**PHOTO 56: CHANNEL DEEPENED AND
WIDENED WITH HOERAM RIGHT OF STA. 46+00**

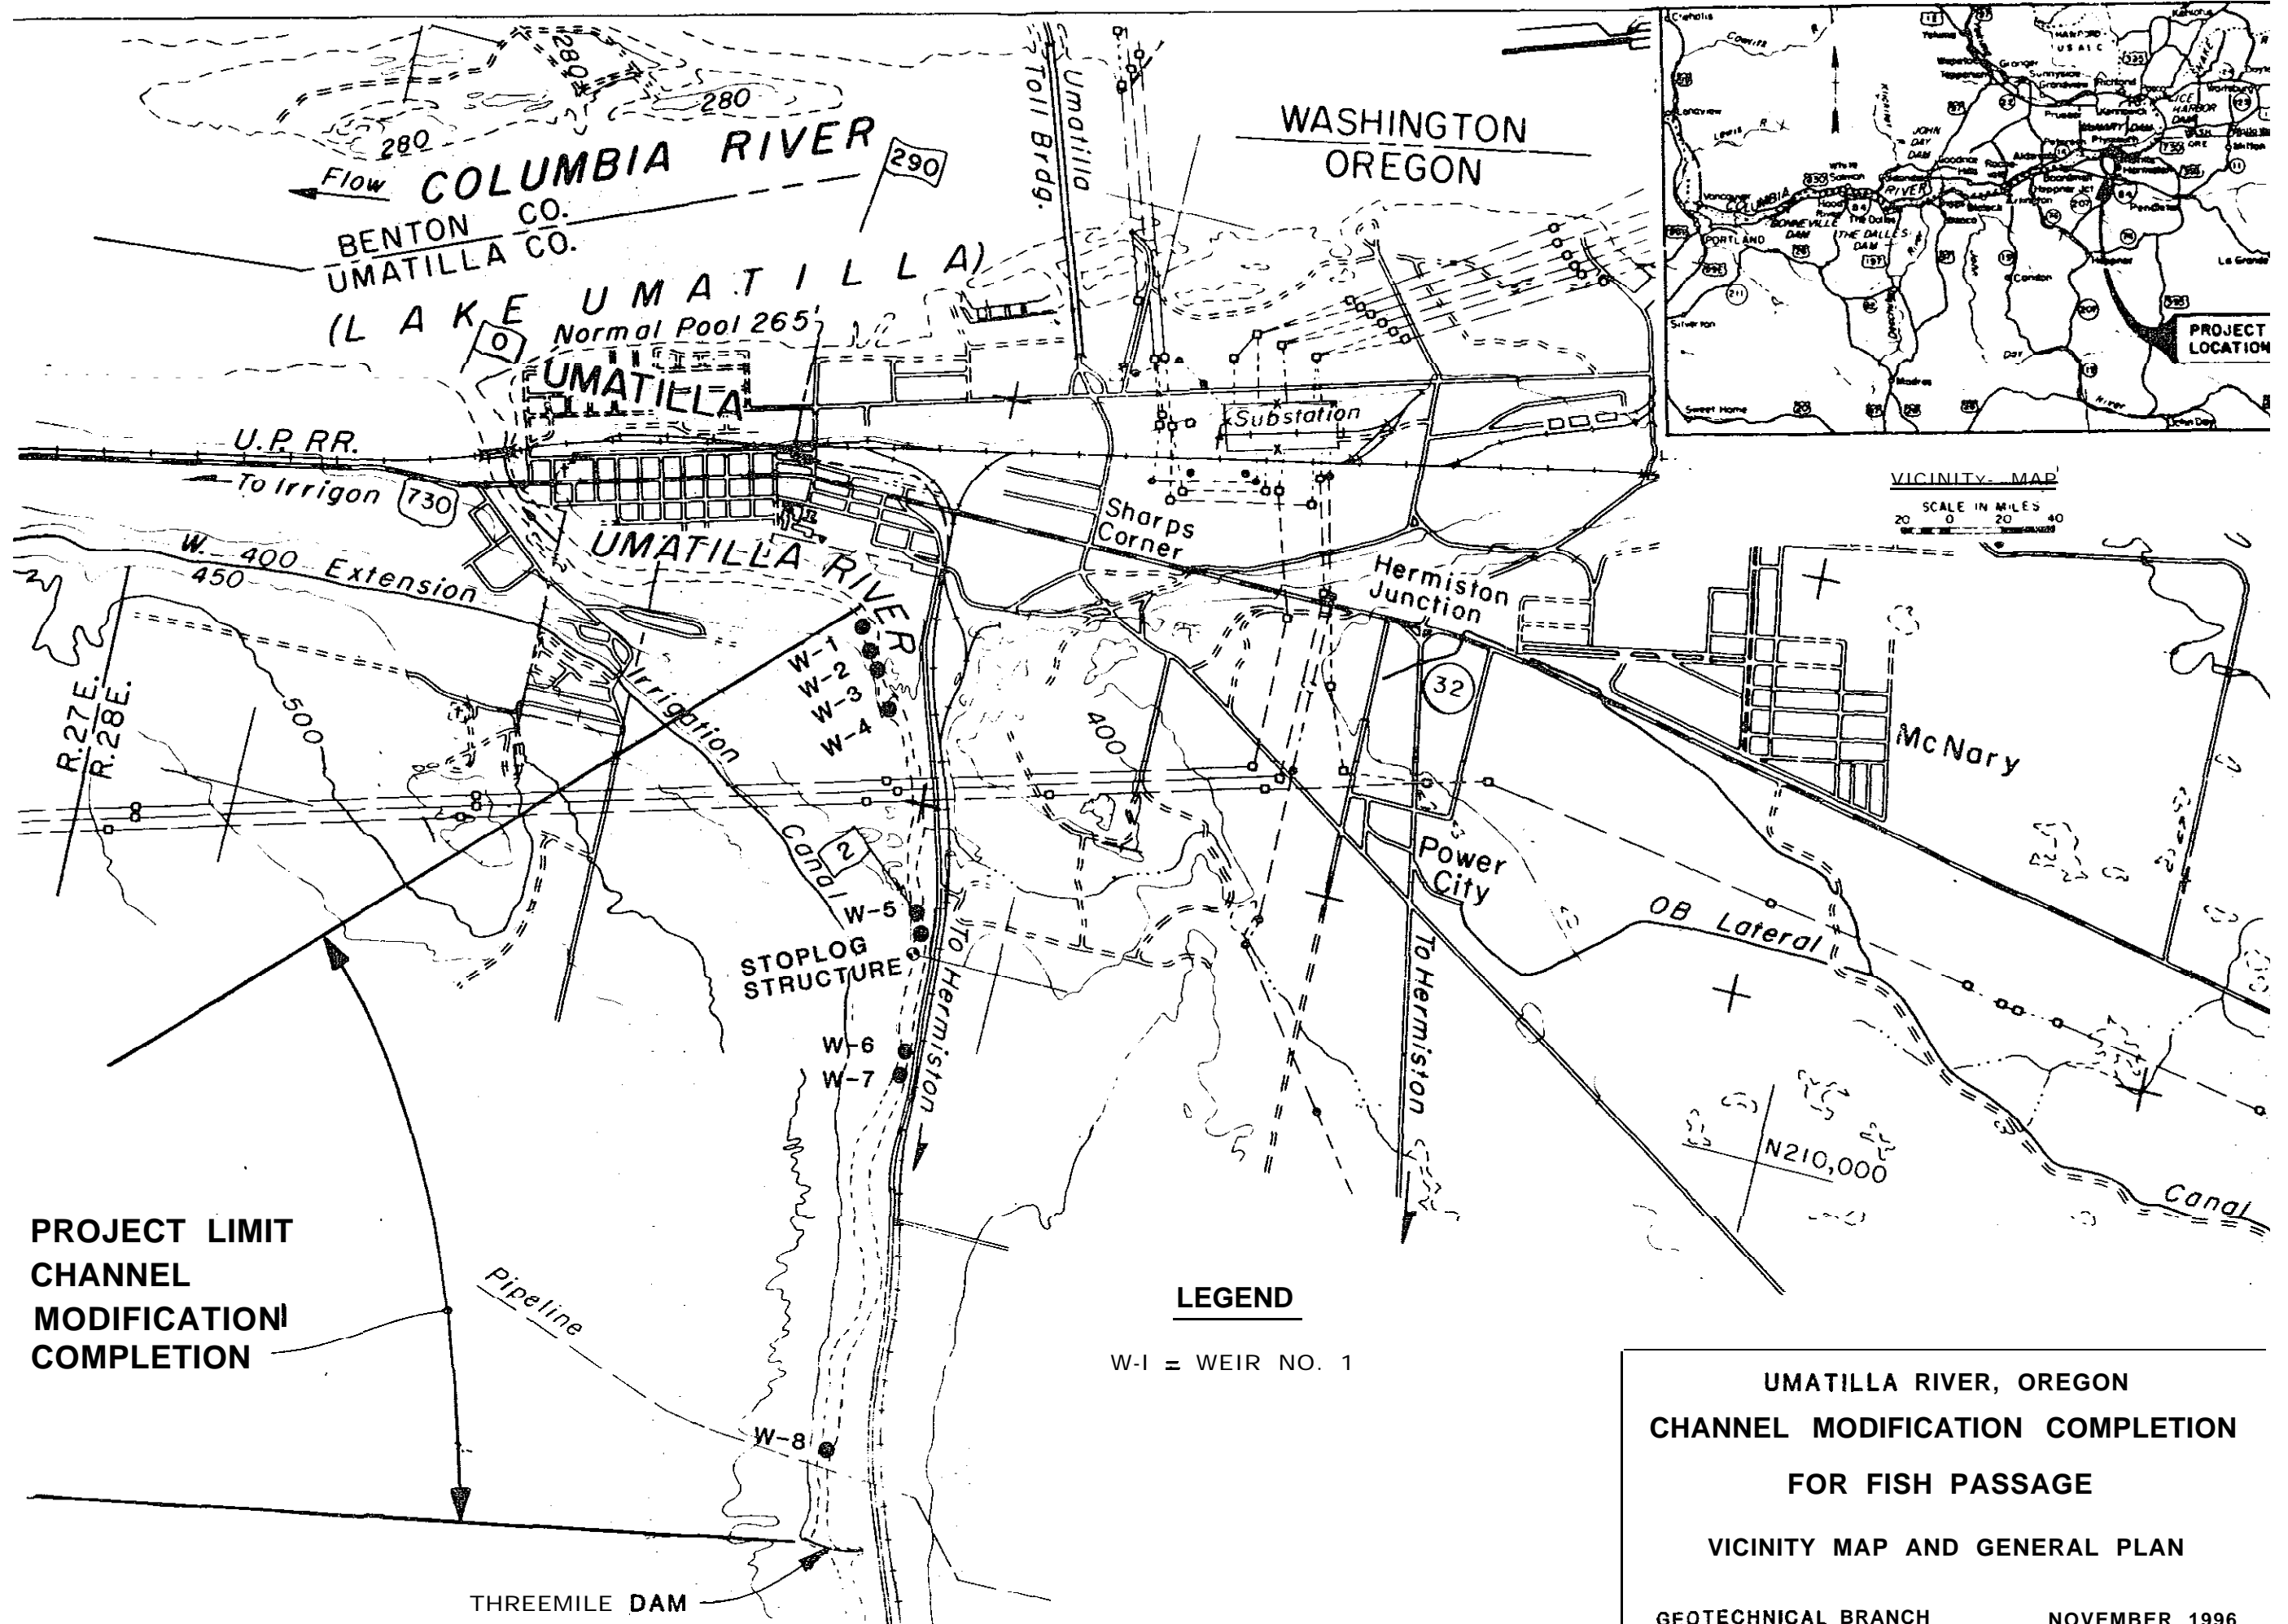
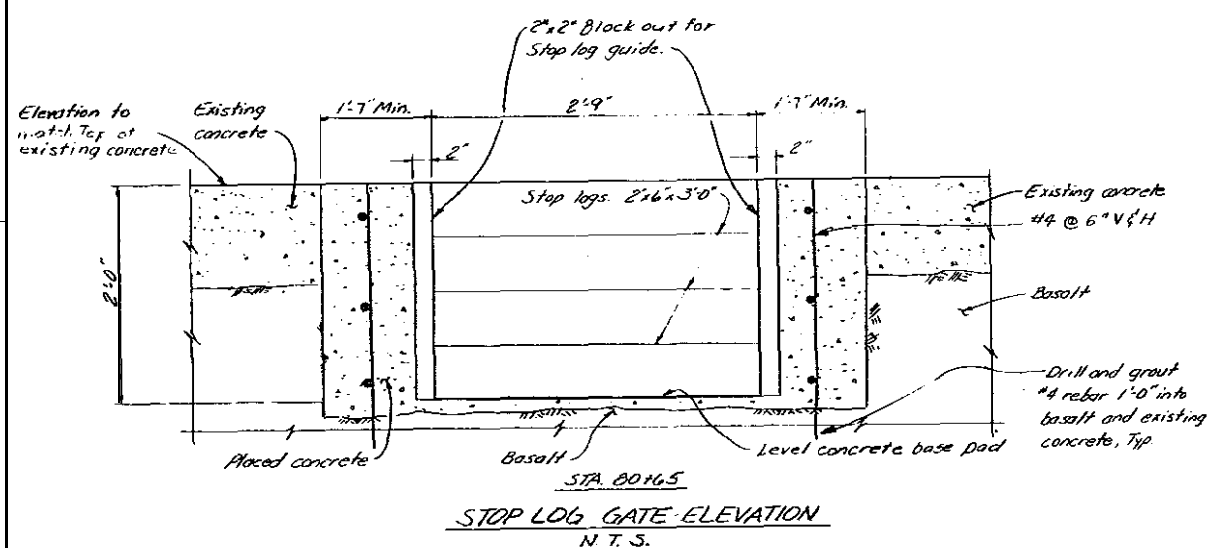
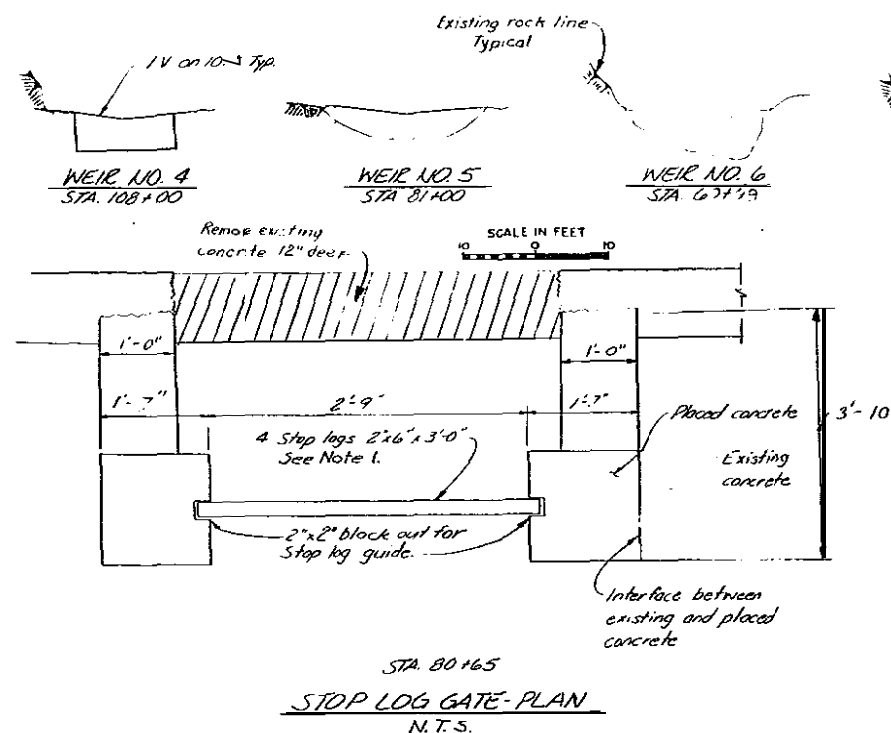
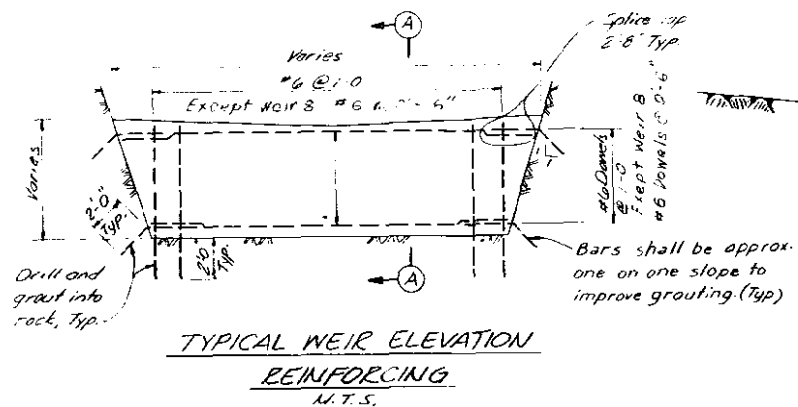
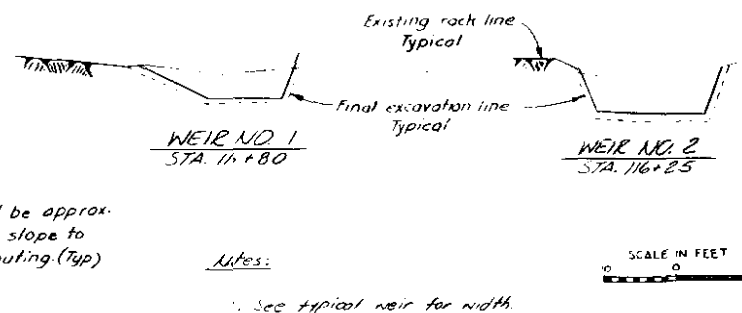
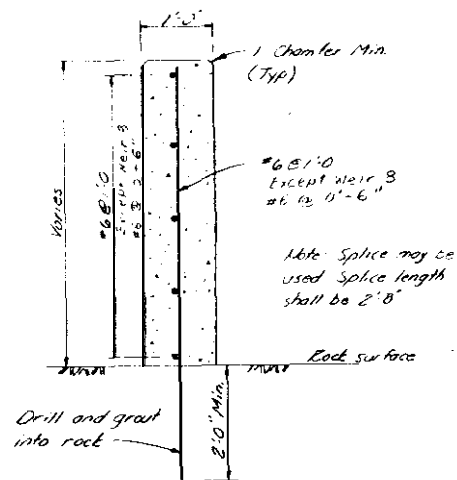
The Umatilla River below Threemile Dam (see Plates 1 and 2) flows directly on Columbia River basalt. The stream gradient from the dam to the river mouth is less than 1 percent. Average streamflows below the dam range from less than 40 cfs from July through September to about 1,000 cfs in March and April. Flows are often less than 2 cfs in July and August during the irrigation season.
